Test Report No.7191110244 - MEC15 - YX
dated 07 Apr 2015

**PERFORMANCE TEST
OF
PARTITION WALL SYSTEM
USING
WELL & ABLE INTERNATIONAL
BESTA™ HOLLOWCORE PANELS OF 90MM THK.**

**TESTED WITH REFERENCE TO
BS 5234: Part 2: 1992 or SS 492: 2001**

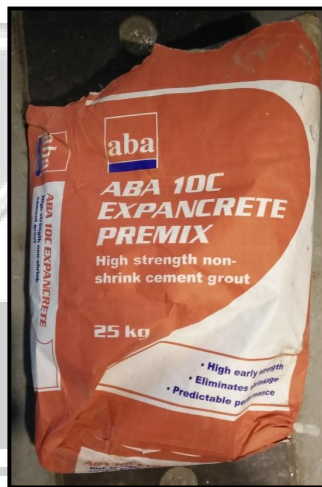
Figure 1: Non shrink grout used for infilling hollow core

- 2.1) Panel Dimension: Length: 2760mm, Width: 600mm, Thickness: 90mm
- 2.2) Compound joint used: GX500 liquid mixed with GX500 powder
- 2.3) Non-shrink grouting used for infilling of hollow core:

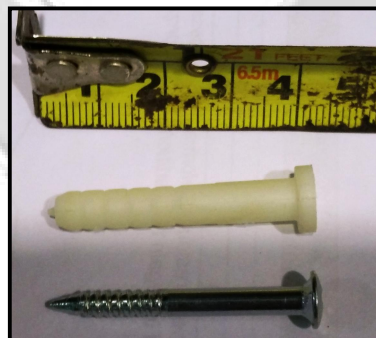
Figure 2: Screw with plastic anchor used for light weight anchorage tests

- 2.4) Screws used for light weight anchorage – pull out and pull down test

The test determines whether the partition wall can withstand light weight fixtures such as those for wall picture, clothing hook and basic wall shelving. A U-shaped steel bracket was secured by the specified anchorage. A shim plate was placed in between the steel bracket and the wall. A load of 20 N (± 1 N) was applied on the shim plate.

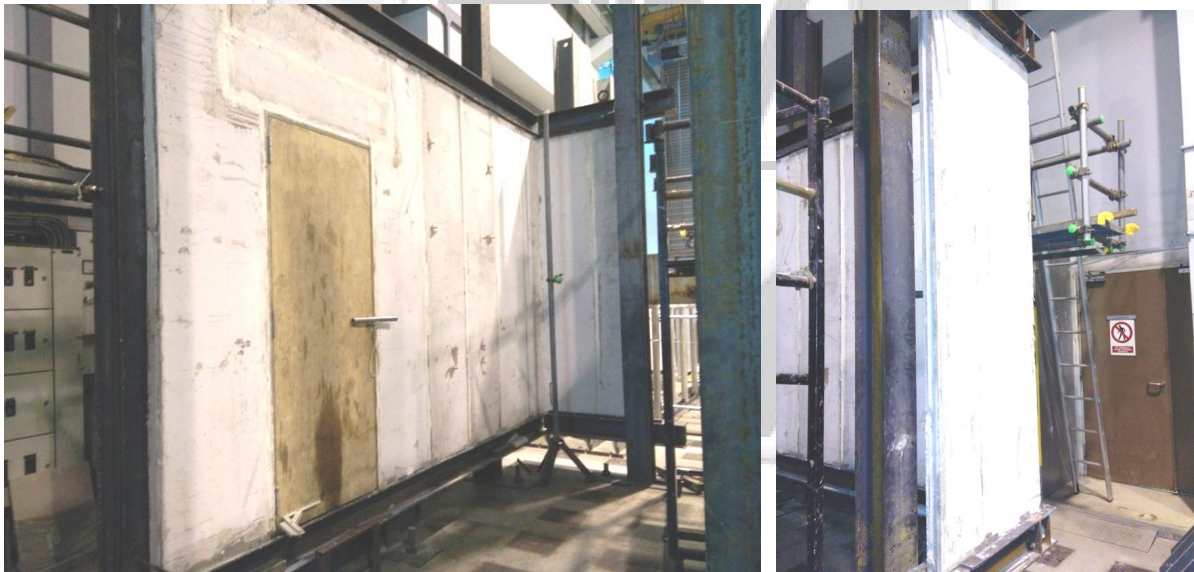
Figure 4: Test specimen mock-up

A mock-up test specimen 2760mm width X 4500mm height and a partition junction assembly of a right-angle corner with a return of 900mm was installed onto the test rig for the performance test. All hollow cores were infilled with non shrink grout. Total, 2 sheets of company's drawings containing the details of the mock-up specimen.

The test specimen includes a door set 900mm width X 2100mm height and a 600mm run of partition flanking at one side of the door set.
