CERTIFICATE OF CONFORMITY

Product : *Fire Rated Partition System*
Brand : *"BESTA™"*
Model : *Besta™ ALC Sandwich Panel*
Country of Origin : *China*
Product Details : *Integrity: 240 mins, Insulation: 240 mins*

Test Report No. S07MEC0023/IHN
dated 31 Dec 2007

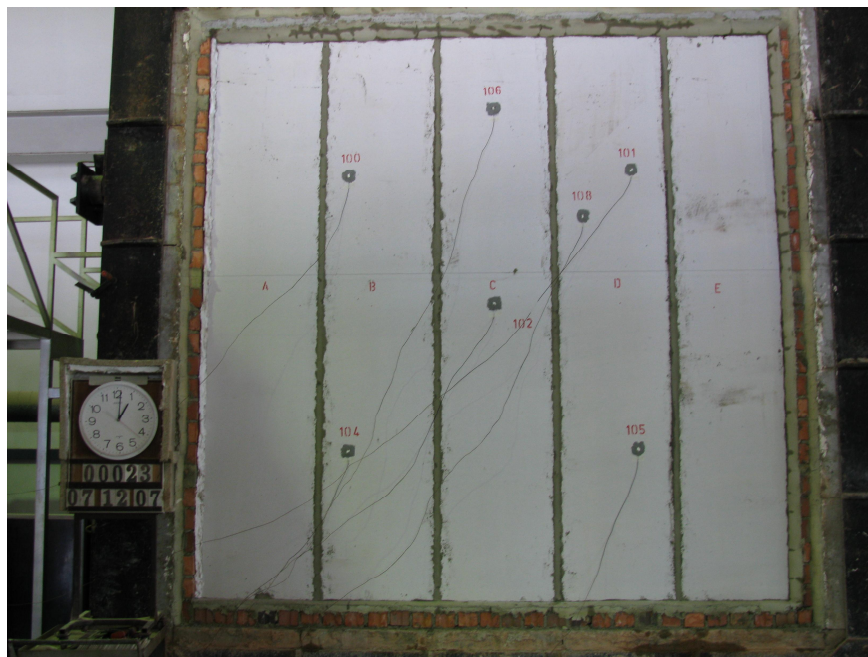
Plate 2: At about 60 minutes of test.

40:00	Slight clearance developed beneath mortar infill between vertical joint of panel D and E at wall mid-height.
60:00	Integrity was observed to remain intact and increased inward deflection across wall mid-height was recorded.
