Fire resistance test on a non-loadbearing 'Besta' hollowcore Almgo panel system submitted by Well & Able International Pte Ltd.

To determine the fire resistance of the specimen when tested in accordance with BS 476: Part 22: 1987: "Methods for Determination of the Fire Resistance of Non-loadbearing Elements of Construction - Determination of the Fire Resistance of Partition".

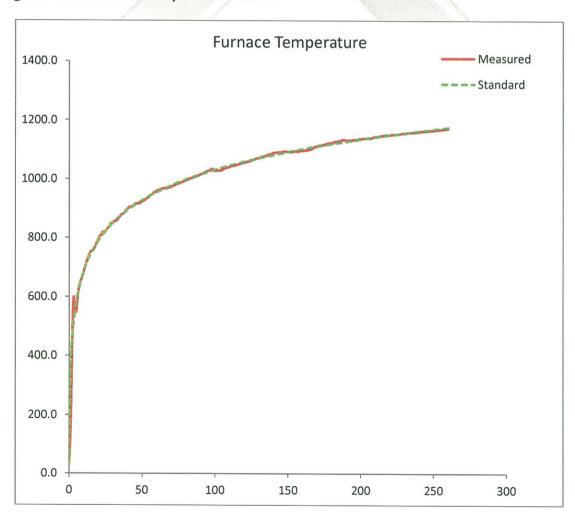
Figure 1 : Time and temperature curve

Time	Temperature rise (°C)		Area under curve (°C min)		Percentage difference	Standard tolerance
(min)	Standard	Furnace	Standard Furnace		(%)	(±%)
5	556.4	519.2	2188.1	1992.2	-9.0	
10	658.4	655.2	5402.7	5179.2	-4.1	15.0
30	821.8	821.4	15692.6	15727.1	0.2	10.0
60	925.3	930.6	27284.3	27272.1	0.0	
120	1029.0	1026.8	88071.6	87945.7	-0.1	
180	1089.7	1094.1	153557.6	153474.4	-0.1	
240	1132.8	1131.7	222096.0	222105.3	0.0	5.0

- 16. Table 4 shows the deflection measurement on the specimen.
- 17. Figure 1 shows the actual time-temperature curve of furnace in relation to the specified time-temperature curve.

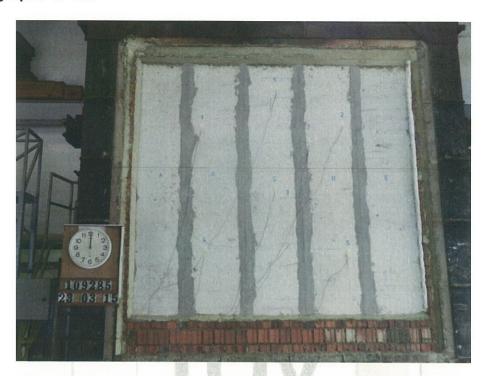
Plate 1: The unexposed face of specimen before the test.

- 18. Photographs of the test are shown in Plates 1 to 4.
- 19. Observations were made during the test on the unexposed face of the test specimen and these are given in Appendix 1 of this report.

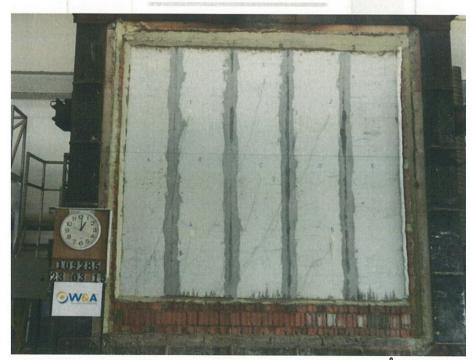
Plate 2: At about 60 minutes of test.

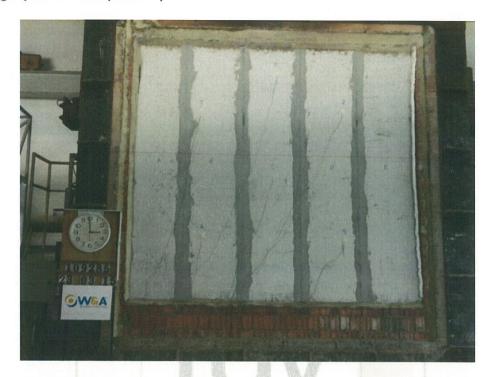
Plate 3: At about 180 minutes of test.

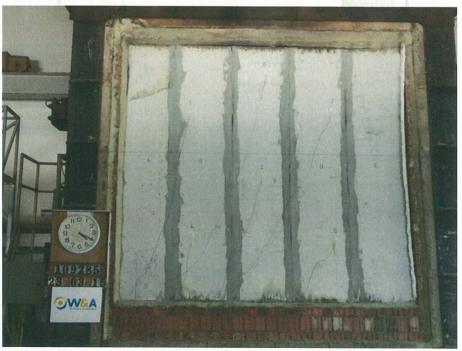
Plate 4: At about 260 minutes of test.

Time (min:sec)	Observation on the unexposed face
00:00	Test commenced.
11:00	Steam emitted along second vertical seam from the left and slight damp on the surface around the location.
17:00	Slight damp on the surface along fourth vertical seam from the left.
29:00	Slight damp along the third vertical seam.
30:00	Wall system remained stable.
55:00	Surface cracks appeared along the vertival seams.
60:00	Wall system remained stable.
90:00	Surface crack appeared on the left panel top location of the system.
120:00	Wall system remained stable.
240:00	Wall system remained stable.
260:00	Test was discontinued. Beside some surface cracks the system remained intact.
